SAFETY ALERT - FAILURE OF MASTERLINK ON FOUR-LEG SLING SET

Incident Date: 7/02/2011

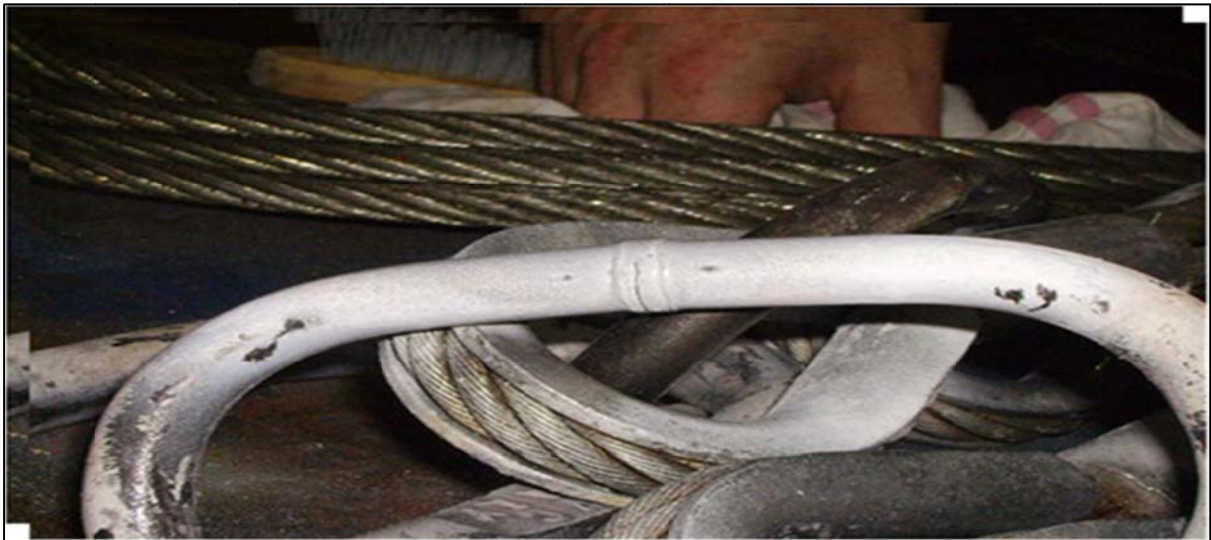
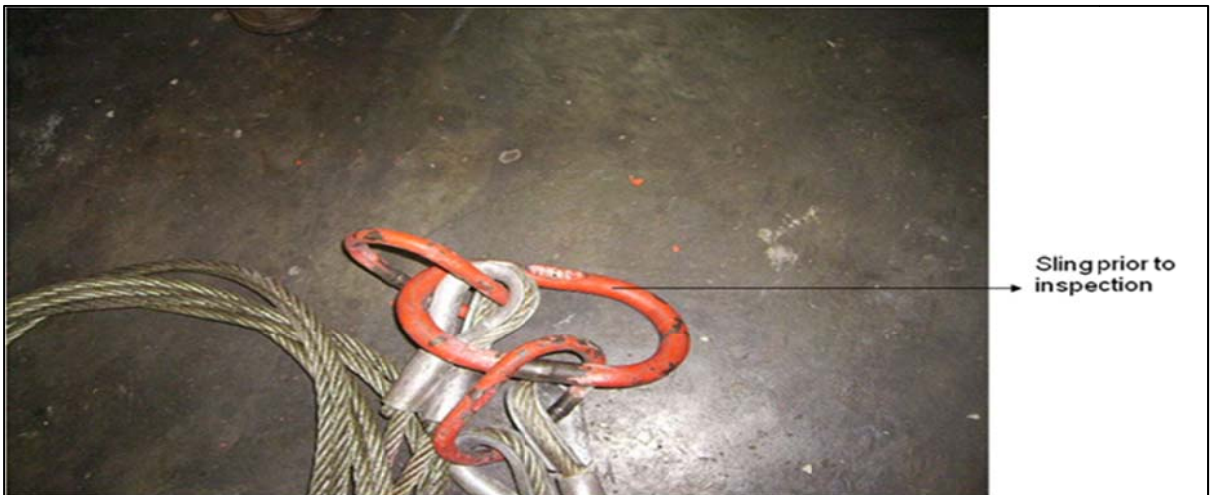
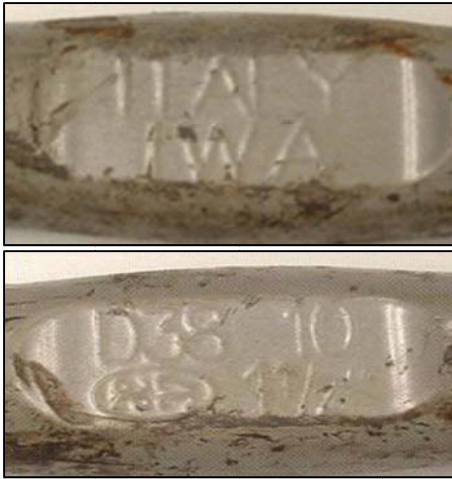
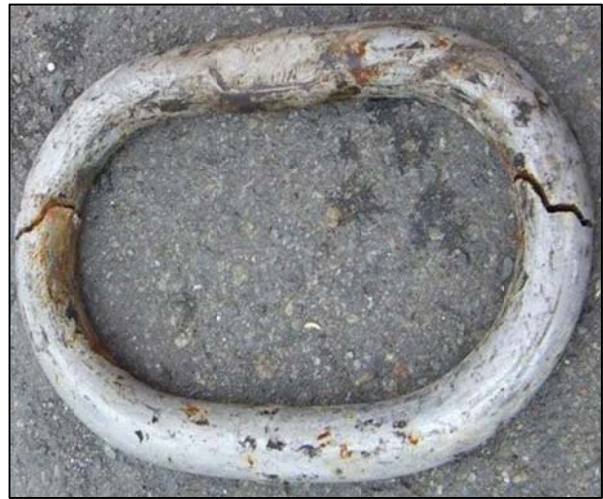
Description: Catastrophic failure of a 275mm x 150mm x 38mm dia 27.7t master-link supplied as a component of a 4-leg wire rope sling-set for a 35t load. This link was one of two sub-master links in the assembly (i.e. It had two wire sling thimbles through it) When the link failed, it was lifting a 5t support frame. Although the actual failure has not resulted in any other damage, under prior circumstances it could easily have had much more serious consequences. It has been even more concerning that follow-up action has so far identified three other master-links in service from the same supplier which have similar cracking such that their failure would have been imminent. The failed link was purchased in December 2010 and was proof tested as an assembly prior to being placed in service as part of an approved offshore construction lifting plan. Investigation continues, determining a single cause of failure may be any or a combination of material quality, dynamic load applied and sling configuration potentially crowding the link space. The cracking has been found in both one grade 100 (supplied painted grey) and three grade 80 (supplied painted red) master links in service. The cracking appears to have emanated from the inside of the link at both the six and twelve o'clock positions.

Specific Equipment: Master Link - 275mm x 150mm x 38mm dia 27.7t (Master link supplied as a component of a four leg wire rope sling-set for a 35t load. This link was one of two sub-master links in the assembly (i.e. It had two wire sling thimbles through it).

Markings are: D38 (38mm dia) Grade 100,

Manufacturer's marking: Weissenfels. Italy & WA marked on Link.

1. Immediate response has been to ban lifting with all master links until the failure cause has been determined and appropriate remedial action taken
2. It is recommended that all users of similar chain and sling sets using this type of master link should immediately check their inventory for any similar potential failures, particularly links from this manufacturer & model type markings.
