## Re: K4 Karabiner Safe Return To Use

Following a well publicised report of a K4 Triple Locking Karabiner breakage, SpanSet Australia Ltd gave an undertaking to publish the findings of the resulting investigation.

*The following is a summary, interpretation, and explanatory notes of this investigation.*

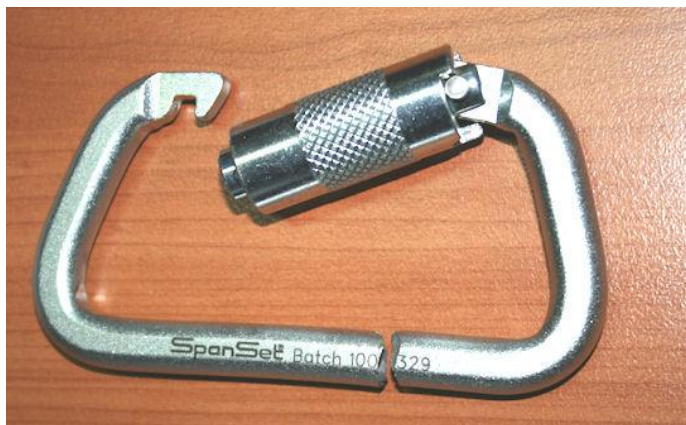
Tensile testing with the gates taped open revealed a retained tensile strength of at least 25kN and reconstructed a near identical break to that reported in the incident ie: breakage through the spine at the retaining pin hole.

Reproduced breakage at 25kN with the gate taped in the open position

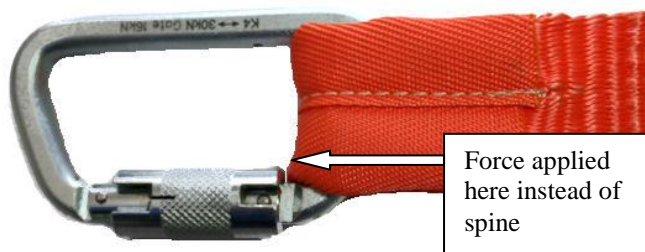
**Fig 2.1 Potential eye crowding**

\*the width of the eye of the safety line or attachment sling Fig 2.1,

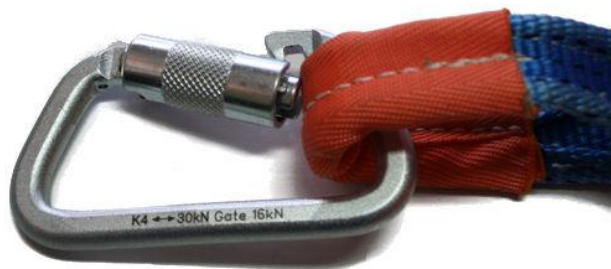
**Fig 3.1 Potential gate jamming**

\*possibly with the gate not fully closed Fig 3.1, 3.2, 3.3.

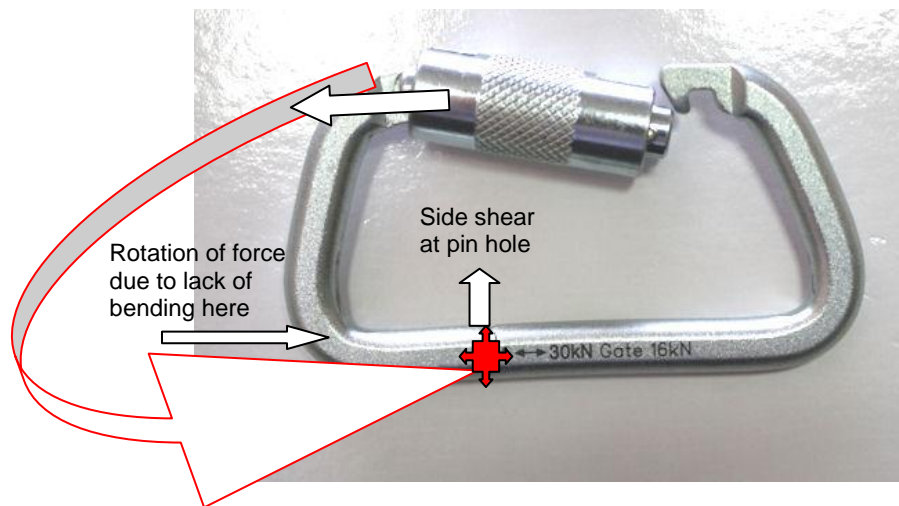
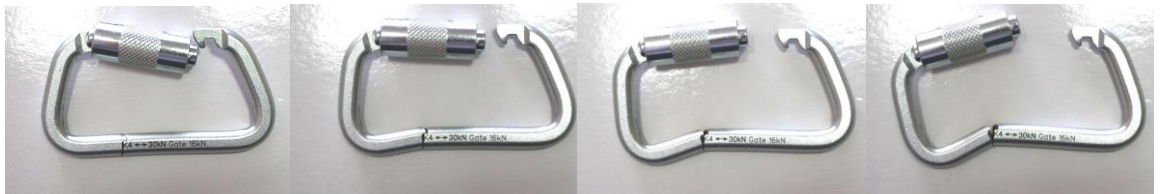
Fig 4.1 Karabiner with high hardness failure point (with gate open)

The karabiner hardness, being at the high end of specification, did not cause the breakage but induced the failure point to move from the gate to the spine, at the retaining pin hole, due to reduced malleability - further indicated by the metallurgical report of side force shear Fig 4.1. This uncommon type of break caused some alarm within the industry, as opposed to the more common gate failure normally seen through overloading, cross gate loading, or other factors.

Manufacturers generally concentrate on minimum hardness levels for high tensile applications. SpanSet Australia has now reversed this to specify maximum hardness and a minimum tensile strength to ensure malleability and consistency.

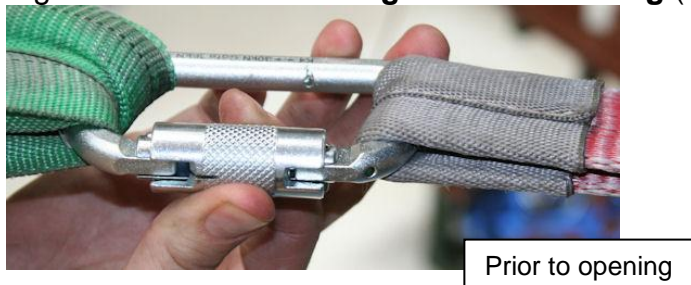
Fig 5.1 Karabiner “flicking” after tensioning (note: gate spring in good order)

- \* A practice known as “flicking” where the karabiner gate is opened and flicked by the operator after loading to check for tension in the line. This can lead to the gate not returning to its closed position due to the karabiner body flexing under load and preventing the pin and nose interfacing correctly.

SpanSet Recommends that the connection interface between static lines and anchorage attachment slings be made via a grade 80, or higher grade lifting component such as a safety shackle, safety bow shackle or self locking latch hook, which will give a higher safety margin and be less susceptible to the above conditions.
