Product Safety Recall

30/07/10

SpanSet K4 karabiners. Batch No 100329

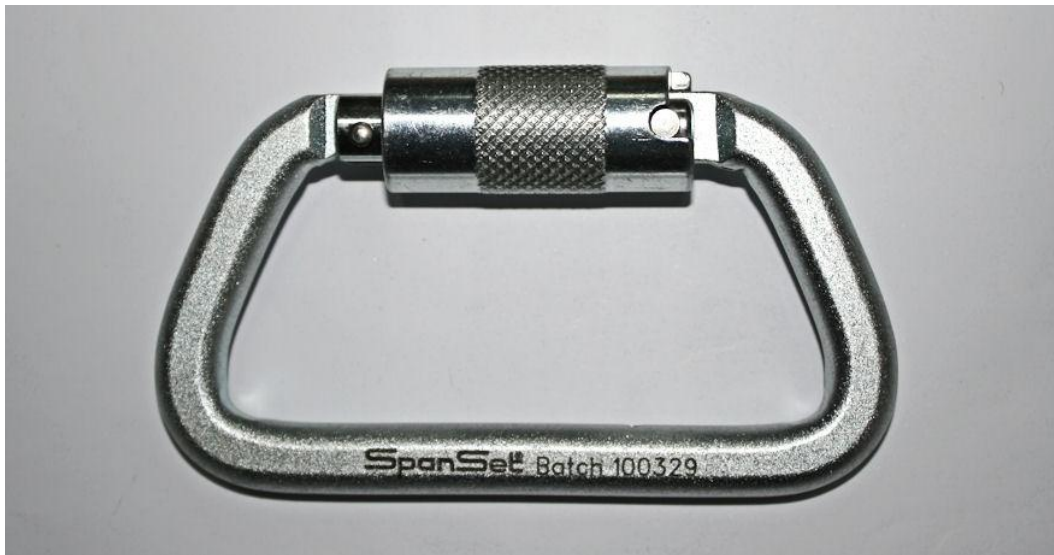
Recently SpanSet Australia investigated the breakage of a 30kn (3000kg) karabiner (SpanSet part code K4) that was used to connect a synthetic safety line which was then tensioned and left overnight. Prior to commencement of work the next day an inspection found the karabiner had broken along the major axis spine, at the receptor hole for the lanyard/webbing retaining pin. SpanSet were given verbal assurance of the correct use by the operator and that only 150kg had been applied to the line.

The affected products can be identified by the karabiner carrying the batch number 100329. This is the only affected component.

Photo of the affected component and batch number

Users have the option of removing the karabiner and returning it to the supplier or SpanSet Australia Ltd for a replacement, or returning the complete product for re-fitting of the newly tested component.

All replacement karabiners will carry the same batch number with a laser etched marking "Tested 8/10" on the top section of the karabiner. This indicates that the component has been proof loaded to 16kN and safe to use. This exceeds the requirements of AS/NZS 1891.1
